# Manhole Inspection Summary

Manhole # **S17GG\_017MH**

Insp Date: **6/12/07 9:55 AM**

**Location** Address: **2200 BAKER ST**

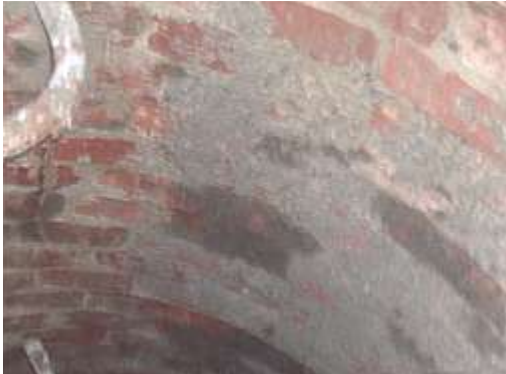
Defect 2

**Corbel** Material: **Brick** ☐ Parged Type: **Concentric/Eccentric**  
Condition: ☐ Sound ☐ Cracked ☐ Root Intrusion ☐ Loose Brick ☒ **Deteriorated**  
Infiltration: ☐ None ☐ Joint ☐ Cracks ☐ Mortar ☐ Roots ☒ **Wall**

INFILTRATION OF CORBEL

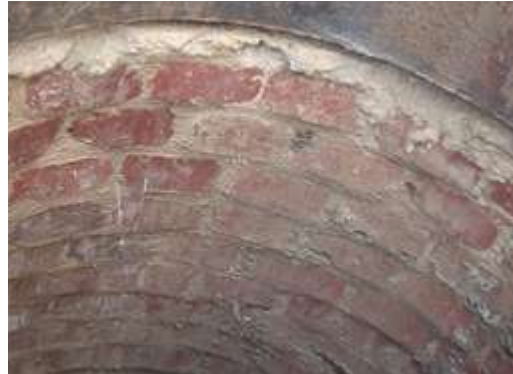
Defect 1

DETERIORATION OF CORBEL

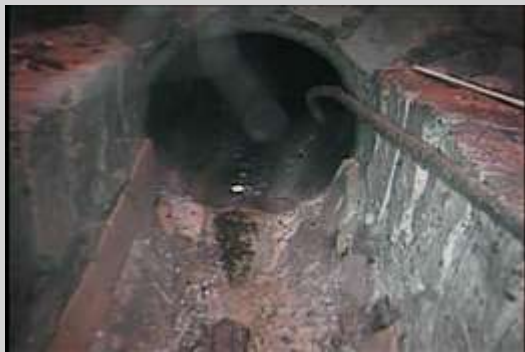
12 O'Clock Outflow

Pipe Height: **8.4** (in.) Rod and Bar (Angled)  
Pipe Material: **Clay** ☐ Pipe Lined  
Invert Depth: **11.16** (ft.) Flow Characteristics: **Slow**  
Deposits: ☒ None ☐ Mud ☐ Sludge ☐ Debris ☐ Grease  
Silt Depth: (in.) Deposits Extent:  
Infiltration: **None** Pipe Seal Cond: **Sound**

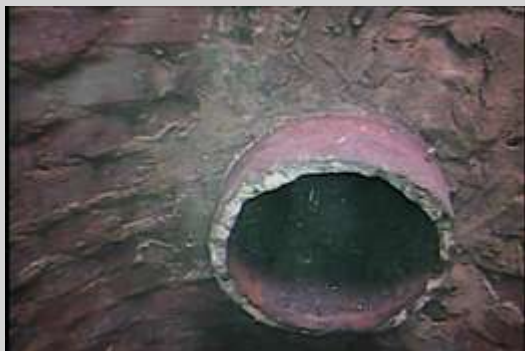
7 O'Clock Inflow

INFILTRATION OF CORBEL

Pipe Height: **8.4** (in.) Rod and Bar (Angled)  
Pipe Material: **Clay** ☐ Pipe Lined  
Invert Depth: **7.52** (ft.) Flow Characteristics: **Slow**  
Deposits: ☒ None ☐ Mud ☐ Sludge ☐ Debris ☐ Grease  
Silt Depth: (in.) Deposits Extent:  
Infiltration: **None** Pipe Seal Cond: **Broken**

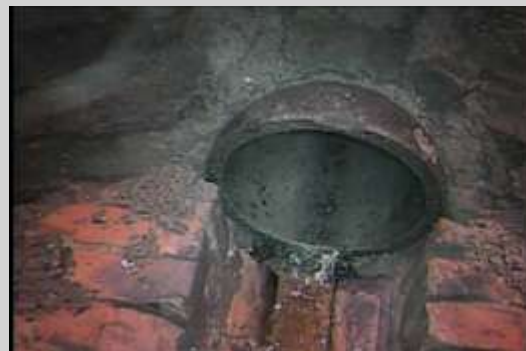
Drop In @ 7 O'Clock

INFILTRATION OF CORBEL

Drop: **Outside** Rod and Bar  
Angled: **Yes** Reading: **9.21** (ft.)  
Inv Depth: **10.21** (ft.)  
Drop Condition: **Open**
